RMS TITANIC

# TITANIC: ENGINEERS

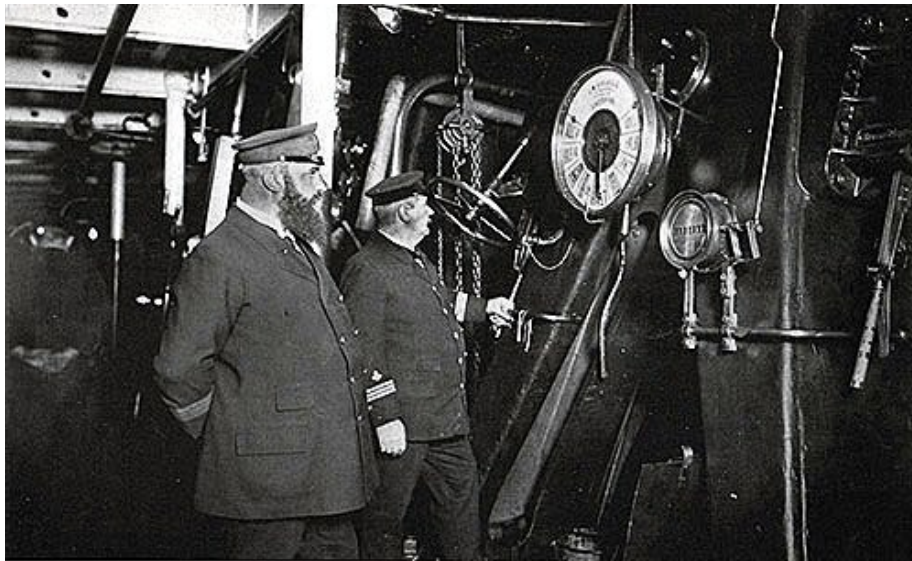
Engineers at the engine telegraph and controls on the starting platform  
Credit: GG Archives

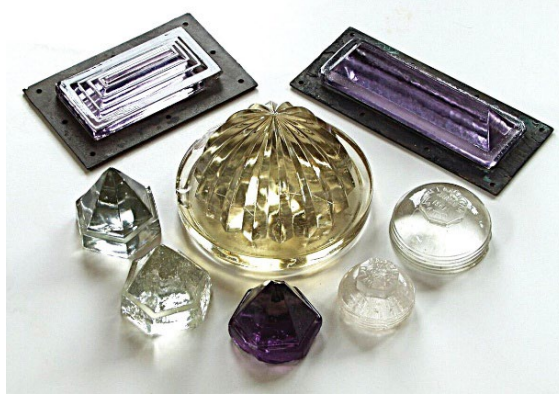
Set of deck prisms  
Credit: Wikipedia

One of the earliest devices to illuminate a ship's interior was the glass prism. Laid flush into the deck, it would diffuse light rays laterally below. Of various shapes and sizes, their simplicity and lack of fire risk rendered them safer than lanterns. In coal-carrying ships, they could detect the start of a fire by concentrating the light of the flame, making it visible on deck. But because they depended on the available ambient light, the amount of illumination they could provide was limited.

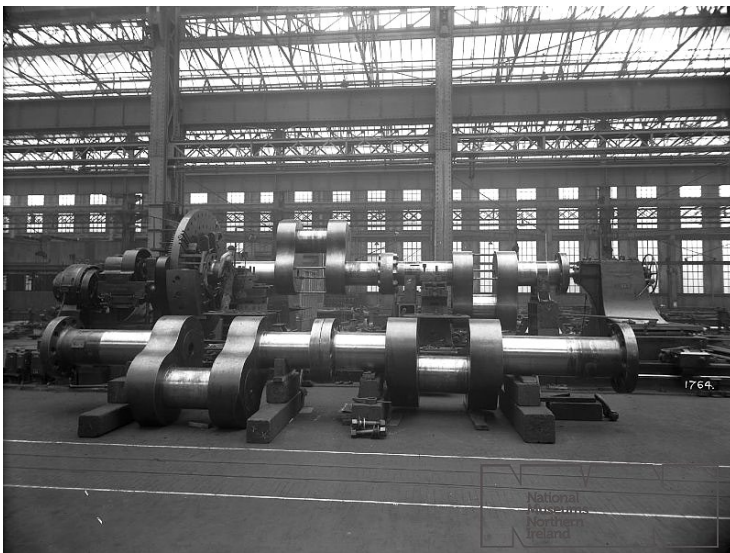
Olympic class ship crankshaft in lathe (background)  
Note offset crank throws  
Credit: Museum of Northern Ireland

Being a new ship on her maiden voyage, the engines had to undergo a careful break-in period. This would allow all the parts to properly wear and fit themselves under correct lubrication, and for properly cleaning away small metal chips that might collect. It was very important that the main journals, crankshaft bearings and piston rings were properly seated.
